DELAWARE RIVER BASIN,
CHESTNUT BRANCH-MANTUA CREEK,
GLOUCESTER COUNTY,
NEW JERSEY.

National Dam Safety Program
ALCYON LAKE DAM

NJ 00427

**PHASE 1 INSPECTION REPORT-
NATIONAL DAM SAFETY PROGRAM**

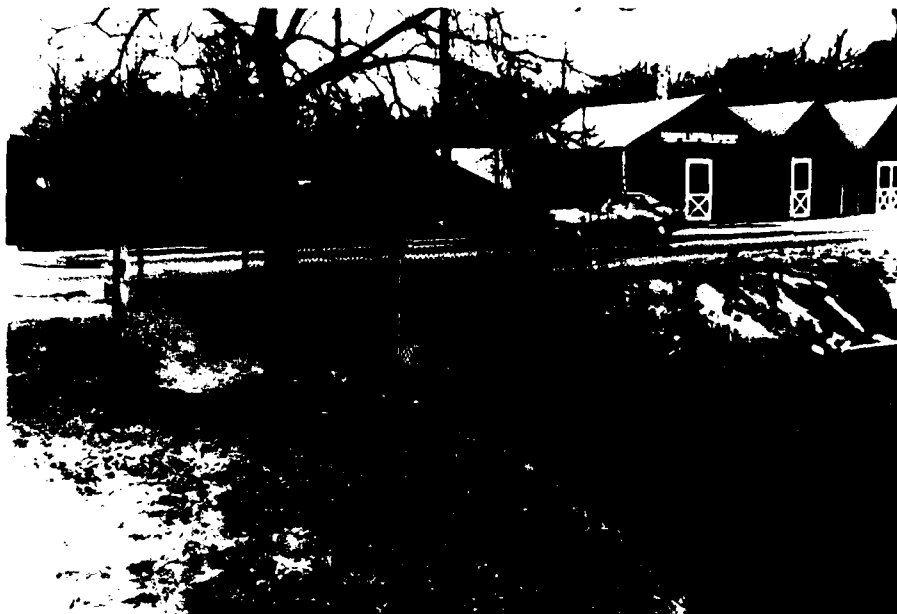
The auxiliary spillway is a 5'-0" diameter steel pipe with an irregular concrete inlet which is blocked up by stoplogs to El. + 84. The pipe appears to be partially blocked up and the stoplogs appear to be immovable. The penstock discharges into the foundations of an old millhouse and hence into a concrete lined millrace which extends about 150 feet downstream.

View of auxiliary spillway inlet

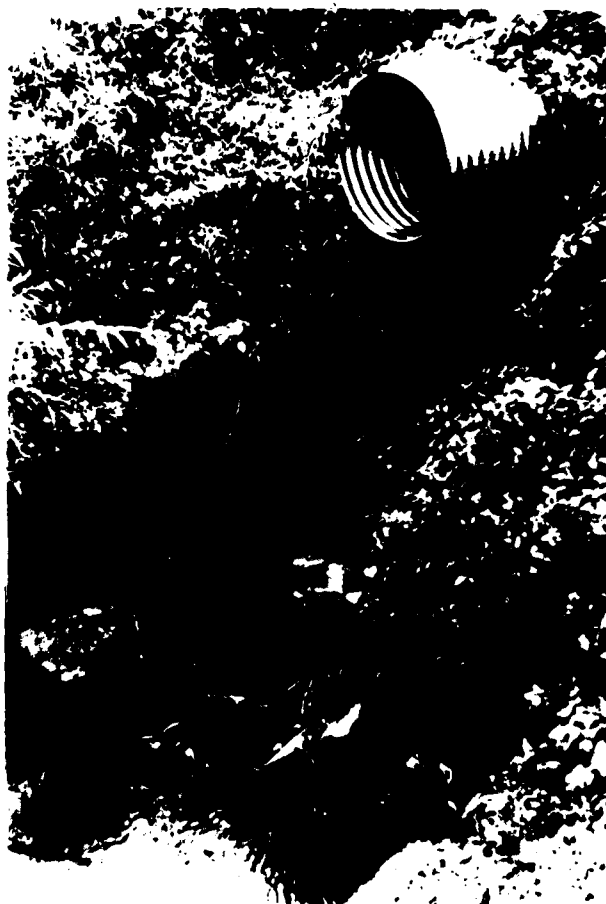
Although no evidence of serious seepage was observed, the downstream condition of the 5 foot diameter penstock pipe (which serves as an auxiliary spillway) could trigger piping problems along the conduit. There is no downstream headwall or any type of anchorage supporting this conduit and it is doubtful if this outlet could withstand extended periods of heavy flow. From the appearance of the stoplogs in the inlet, this conduit has not been touched or maintained in many years.

View of auxiliary spillway outlet

(1) The downstream slopes in the vicinity of the main spillway wingwalls and the auxiliary spillway outlet should be regraded and further protected with a slope paving.
